Oversensing Associated with Seal Plug Integrity

SUMMARY

Products Referenced

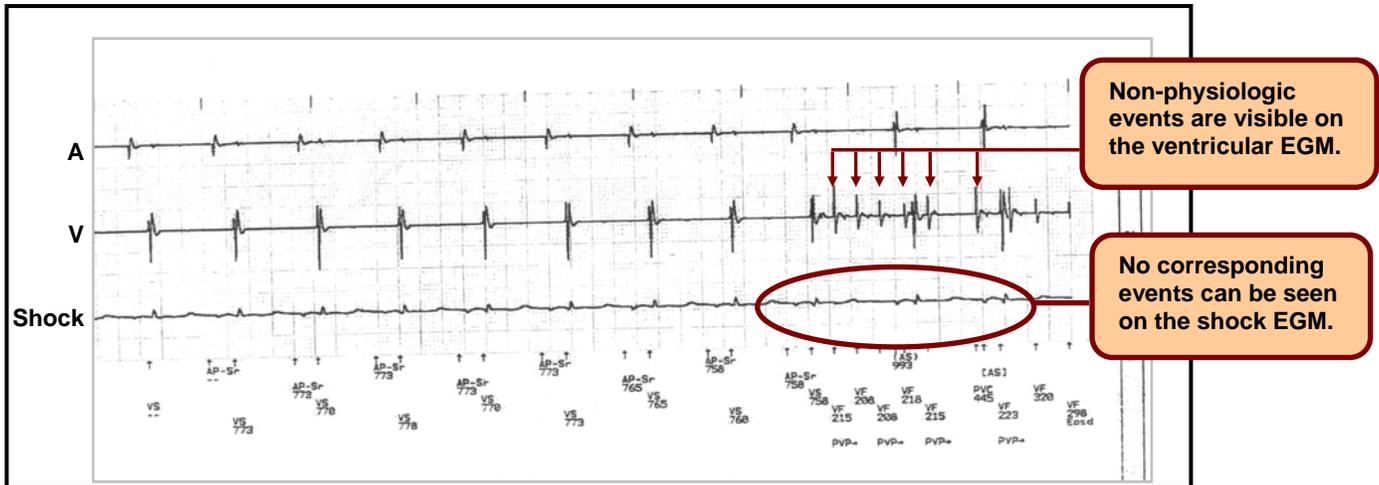
The silicone rubber used for seal plugs has a "shape memory". Inserting a wrench to operate a setscrew stretches the rubber, and seal plugs may require a short time to reseat following removal of the wrench. Until the seal fully closes, infiltration of body fluid from the implant pocket into the device header may create a temporary accessory sensing pathway. If air is trapped in the header during the lead insertion process, it may escape through the seal plug, momentarily displacing body fluid and disrupting the conductive accessory pathway. This momentary disruption causes a change in impedance of the accessory pathway, which generates an artificial (non-physiologic) noise signal capable of inhibiting pacing pulses. Oversensing of this type is sporadic and unlikely to cause either extended inhibition of brady pacing or inappropriate shocks in a defibrillator. This form of oversensing is rarely seen beyond implant and disappears once the seal plug returns to its normal closed position, the entrapped air has dissipated, and pressure equilibrium within the header has been achieved^{1, 3, 4, 5}.

Figure 1 provides an example of oversensing caused by air escaping through a seal plug following wrench insertion. Depending on which seal plug is compromised, this type of non-physiologic noise may appear on the atrial or ventricular EGM, with no corresponding event appearing on the shock EGM or on the surface electrocardiogram (ECG). The noise signals appear as single events of short duration, similar to intrinsic heart activity. One deflection is created for each escaping air bubble. **NOTE:** These noise signals are different in appearance than other physiologic signals (such as pectoral or diaphragmatic signals), which typically demonstrate more erratic amplitude and frequency characteristics (Figure 2).

Figure 1. EGM indicating non-physiologic oversensing due to air bubbles escaping header through seal plugs.

If sporadic oversensing of this type is observed, it will typically resolve spontaneously without intervention within 24 hours after initial presentation.

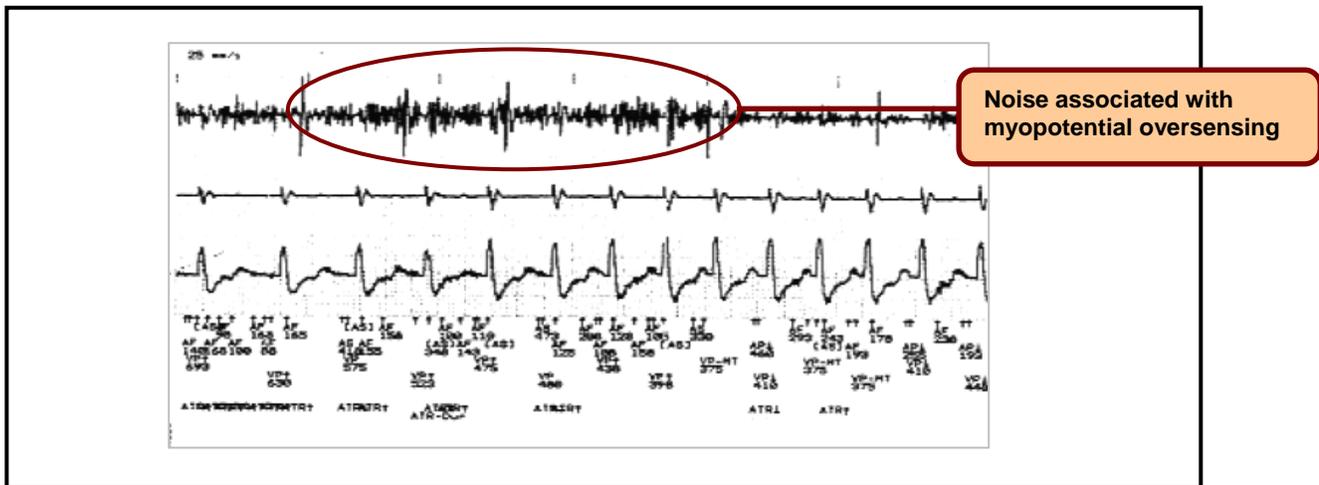
Figure 2 provides an example of oversensing of pectoral myopotentials when a seal plug is damaged (torn) or is missing altogether. The accessory sensing pathway caused by significant seal plug damage may cause chronic oversensing of skeletal/pectoral muscle signals. This type of oversensing is typically visible on stored EGMs viewed at implant or during routine patient follow-up. Signals associated with this type of seal plug damage are typically irregular in frequency and amplitude and occur for more cardiac cycles^{6, 7}.

Figure 2. Example of oversensing of pectoral muscle activity due to significant atrial seal plug damage.

Oversensing of pectoral muscle activity facilitated by seal plug damage may cause extended pauses in pacing, asynchronous pacing (noise mode) or unnecessary shocks. Standard troubleshooting procedures should be followed to identify and correct oversensing of this type, keeping in mind that other causes, such as lead insulation abrasion, loose setscrews, sub-optimal lead position and lead conductor fracture can yield similar clinical observations and are other plausible root causes to be considered.
