## Beeping Tones Associated with “Out-of-Range” Shock Lead Impedance

### CRM PRODUCTS REFERENCED\*

VITALITY® HE,  
 CONTAK RENEWAL® 3 / 4 / HE,  
 CONTAK RENEWAL 3RF / 4RF,  
 CONTAK RENEWAL 3RF HE / 4RF HE,  
 CONTAK RENEWAL 3 AVT / 4 AVT,  
 CONFIENT®, and LIVIAN®

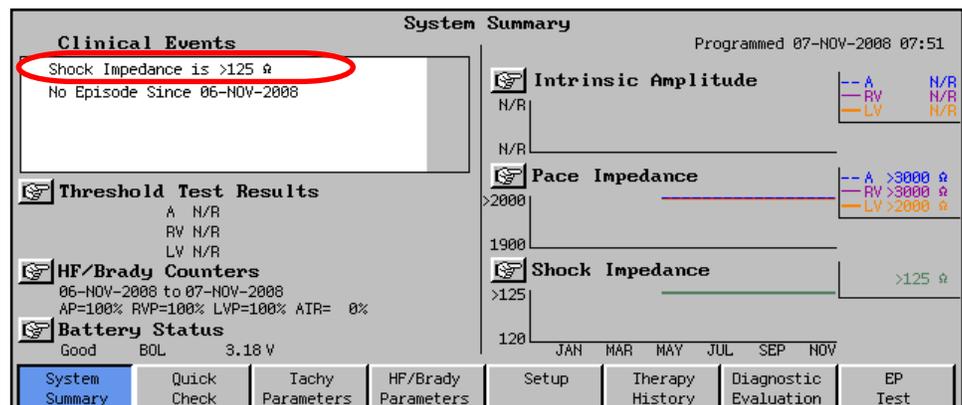
In addition to visual indicators displayed on the programmer (Clinical Events and/or yellow warning messages), some Boston Scientific defibrillators also emit an **audible indicator** to alert patients/clinicians when the device has detected an “out-of-range” shock lead impedance measurement. These two indicators are triggered by impedance measurements of less than 20 ohms ( $\Omega$ ) or greater than 125  $\Omega$ .

Upon the first programmer interrogation following detection of an out-of-range shock lead impedance value, a message will display in the Clinical Events window of the System Summary screen (Figure 1). Additionally, for those devices enrolled in LATITUDE Patient Management System, an out-of-range value also triggers a red alert.<sup>1</sup>

Figure 1. System Summary screen displaying shock lead impedance outside the normal range.

Any time an out-of-range shock lead impedance condition is reported, clinicians should conduct standard lead testing and troubleshooting procedures to identify root cause and resolve the issue. For assistance with any out-of-range messages, please contact a local Boston Scientific CRM representative or CRM Technical Services.

Once the underlying reason for the out-of-range measurement is understood and resolved, the Clinical Event should be reset as outlined in Figure 2. **Resetting the Clinical Event will terminate the beeping tones.** Until the Clinical Event message window is reset, additional Clinical Events/LATITUDE alerts for out-of-range shock lead impedance will not be generated, and the device will continue to emit beeping tones every six hours.
